NACA RM E54K23

AN EXPERIMENTAL EVALUATION OF SEVERAL DESIGN
VARIATIONS OF HOLLOW TURBINE BLADES FOR
EXPENDABLE ENGINE APPLICATION

By W. C. Morgan and R. H. Kemp

WASHINGTON
February 23, 1955

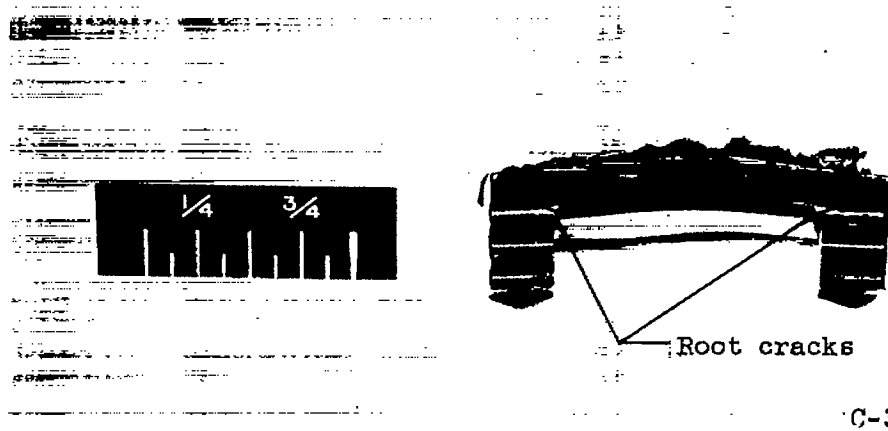
Group 1. - (L-605, 0.030-in. wall, all-welded, fig. 3, base D.) All of the six specimen blades failed in less than 10 hours. The immediate cause of failure was deformation in the base. Figure 9 shows the type of failure. It was noted also that the weld penetration was not uniform

in the base attachment. The results indicated that this type of base is of insufficient strength and that the relative disparity in mass between the airfoil and the base is unfavorable for welding.

Figure 9. - Failure of Group 1 sheet-metal blade showing the excessive base deformation and location of root cracks.

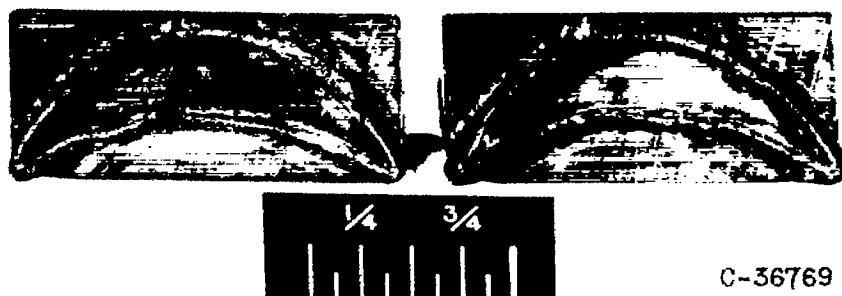
Group 2. - (L-605, 0.030-in. wall, all welded, fig. 3, base C.) In this group of blades the importance of sound welding was exemplified. All six blades failed because of imperfect weld penetration; four blades failed in less than five hours. Figure 10 shows typical failed specimens. Automatic machine weld might prove to be more effective in making joints of this type.

Figure 10. - Two failures of Group 2 sheet-metal blades showing the imperfect weld penetration.

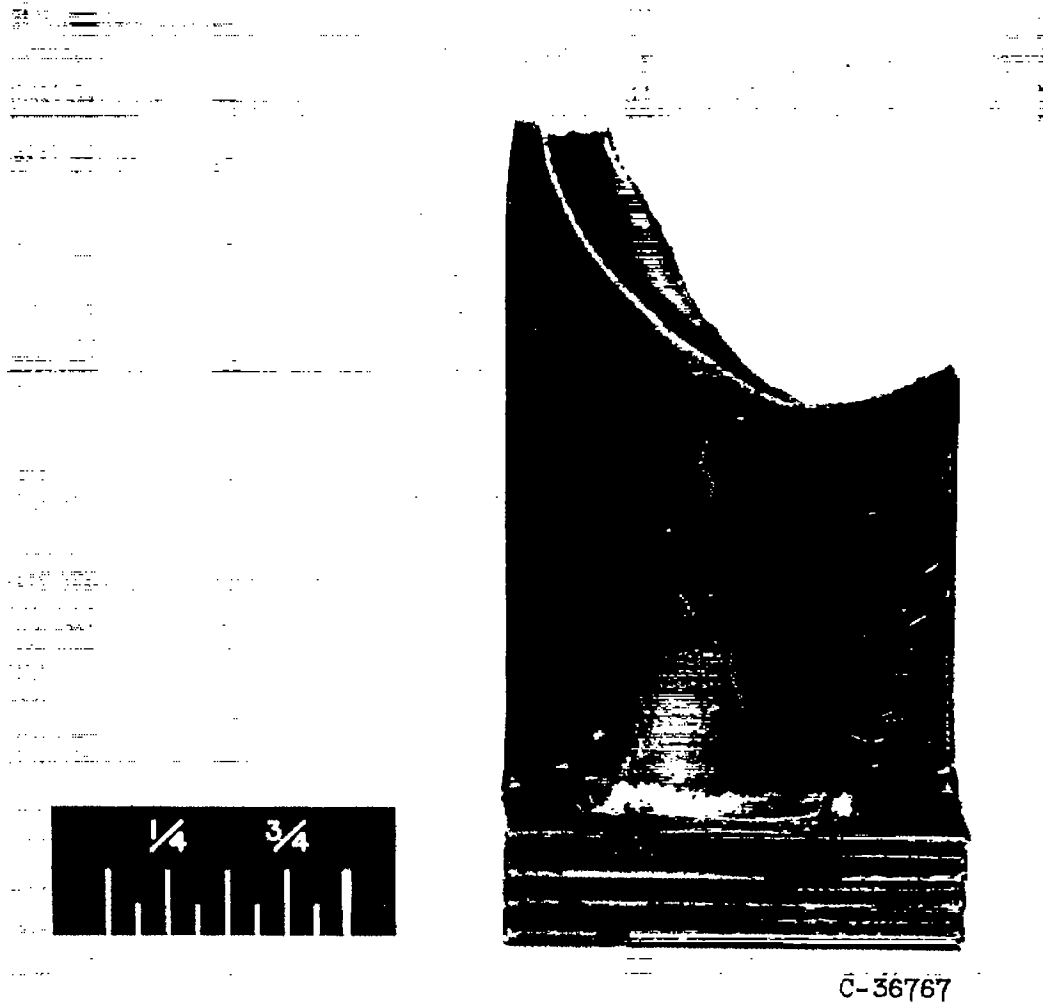
Group 5. - (L-605, 0.025-in. wall, welded airfoil brazed to stub, fig. 3, base A.) One blade failed as a result of excessive clearance in the brazed attachment. Three blades were removed from testing because of failure in the airfoil at the midsection. Two blades were still intact after 30 hours of operation. The failures appeared to be the result of fatigue. Figure 13 shows a representative failure in the airfoil midsection.

Figure 13. - Mid-section airfoil failure in Group 5 sheet-metal blade suspected to have been caused by fatigue.

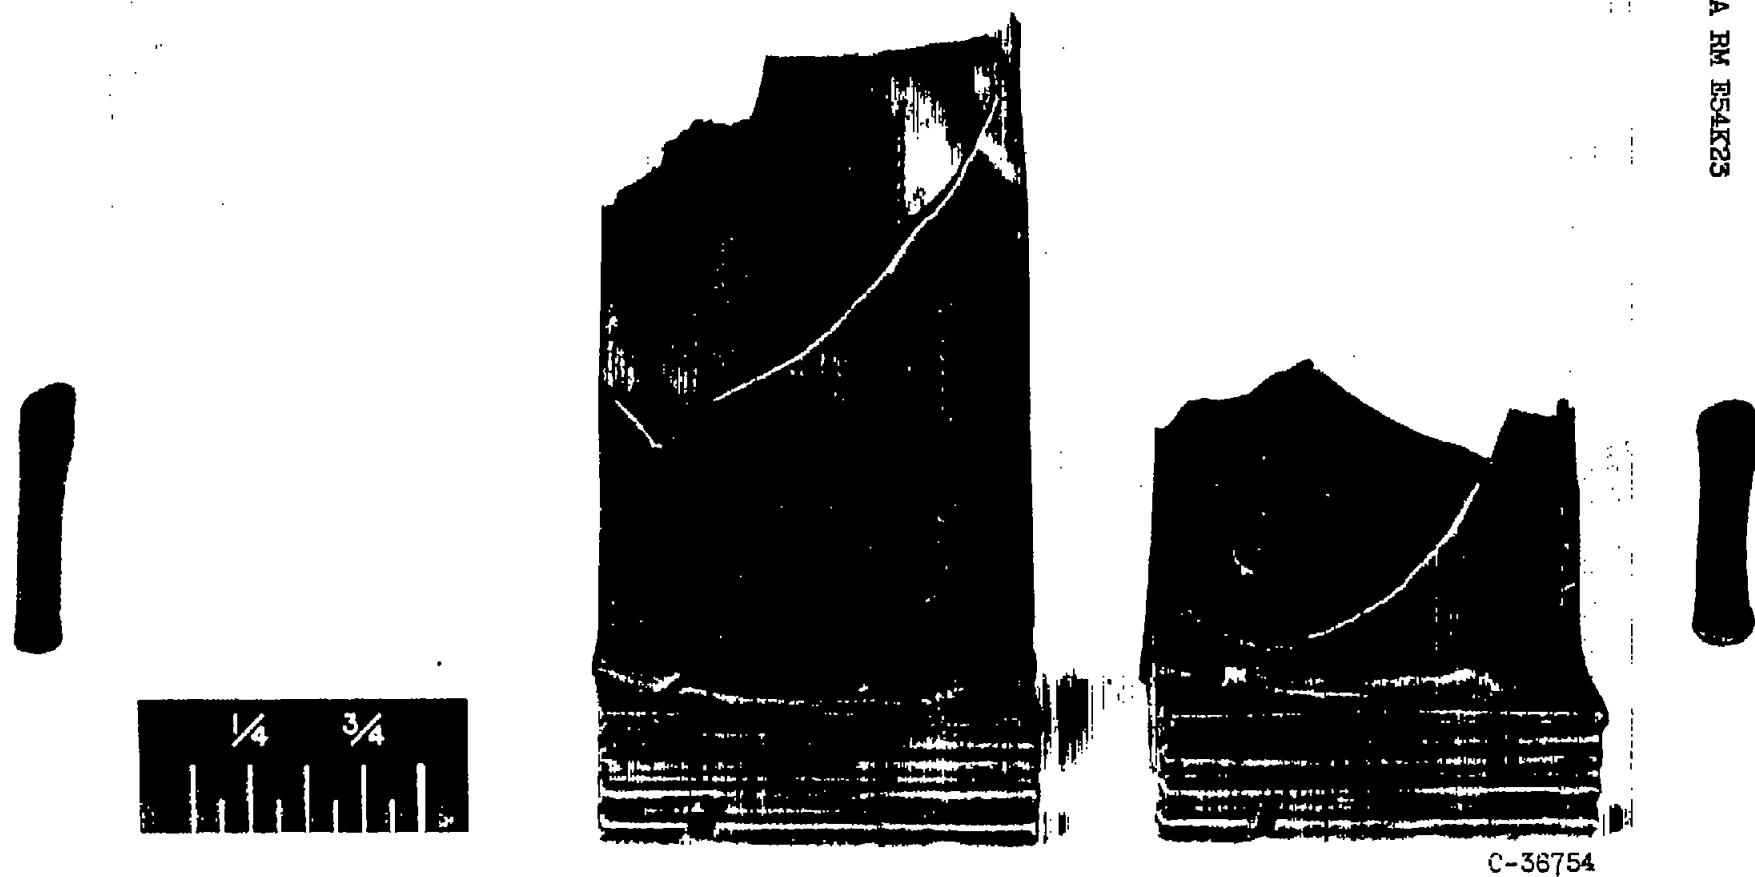
Group 6. - (L-605, 0.022-in. wall, welded airfoil brazed to stub, fig. 3, base A.) Failure occurred in less than 10 hours of operation for the six blades of this group. Serious cracking or actual rupture in the airfoils occurred near the base, the midsection, and the tip. Figure 14 presents typical failures. It is probable that the decrease in structural rigidity caused by the relatively thin airfoil wall made this type of blade particularly susceptible to vibration.

Figure 14. - Typical failures of Group 6 sheet-metal blades suspected to have been caused by fatigue.

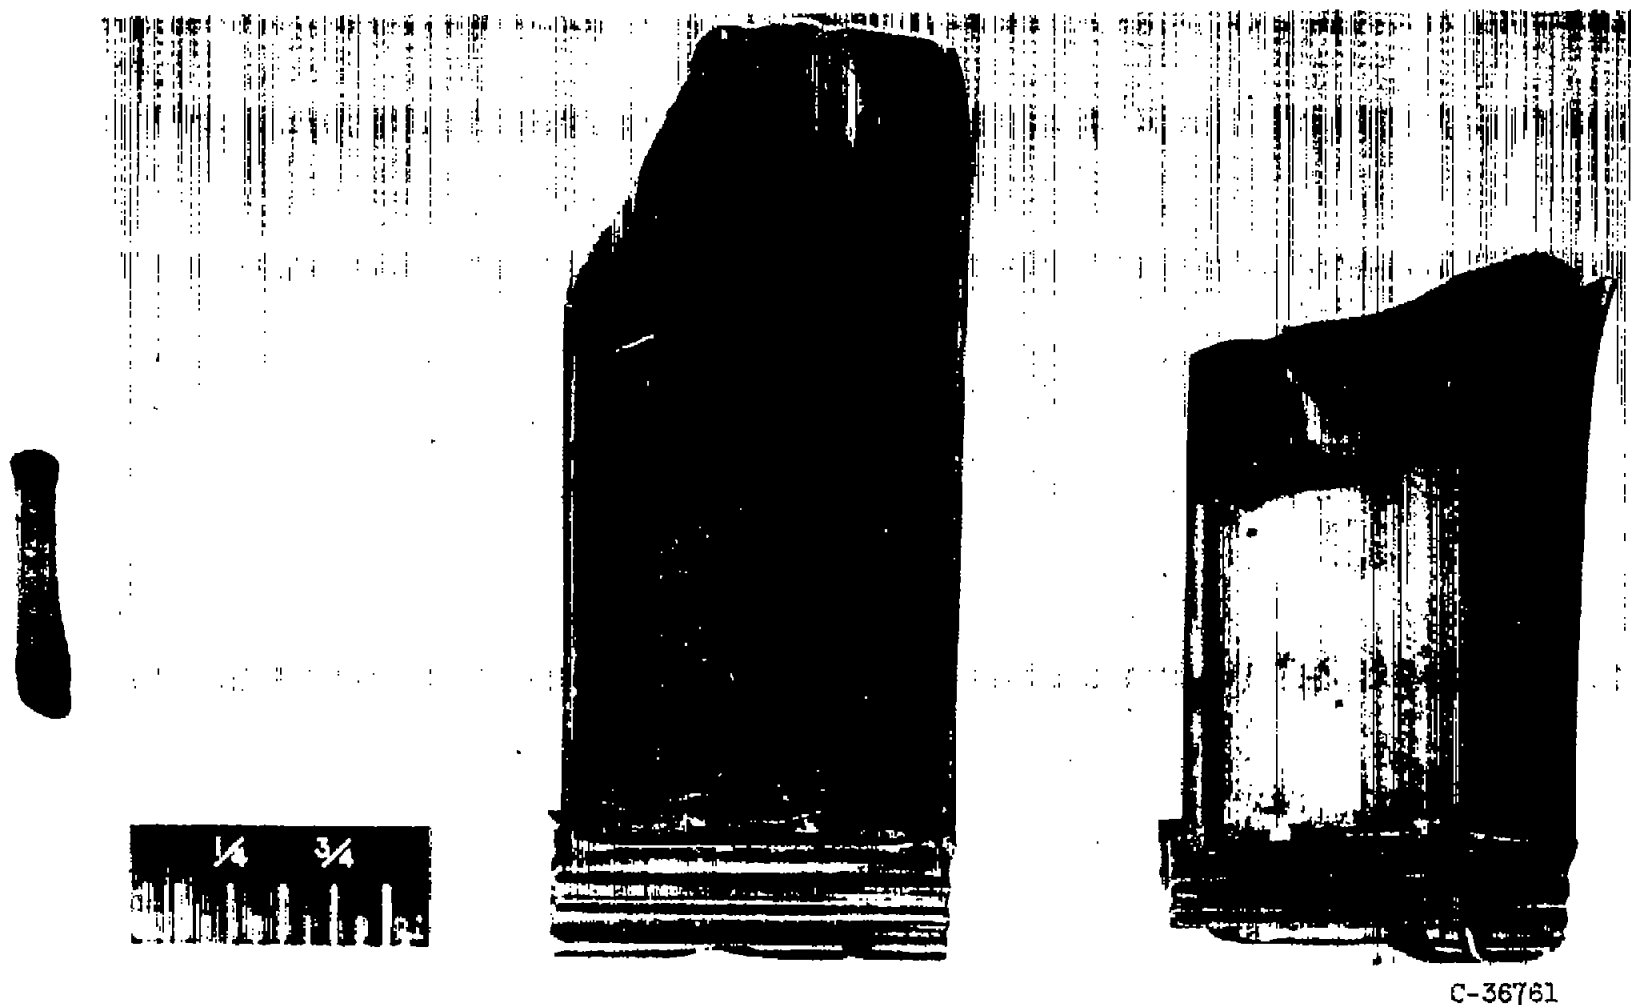
Group 8. - (L-605, 0.030-in. wall, airfoil formed from tubular stock brazed to stub, fig. 3, base A.) Five of the blades tested were undamaged after 30 hours of operation. Seven were withdrawn from the test after sustaining tip failure. Two blades failed near the base, and another blade received excessive impact damage. The majority of the failures originated in the leading or trailing edge, probably as a result of severe bending during fabrication or of inadequate trailing-edge brazing. Two of the failures are shown in figure 15.

Figure 15. - Airfoil failures of Group 8 sheet-metal blades attributed to cracking caused by the forming operation and to imperfect edge brazing.

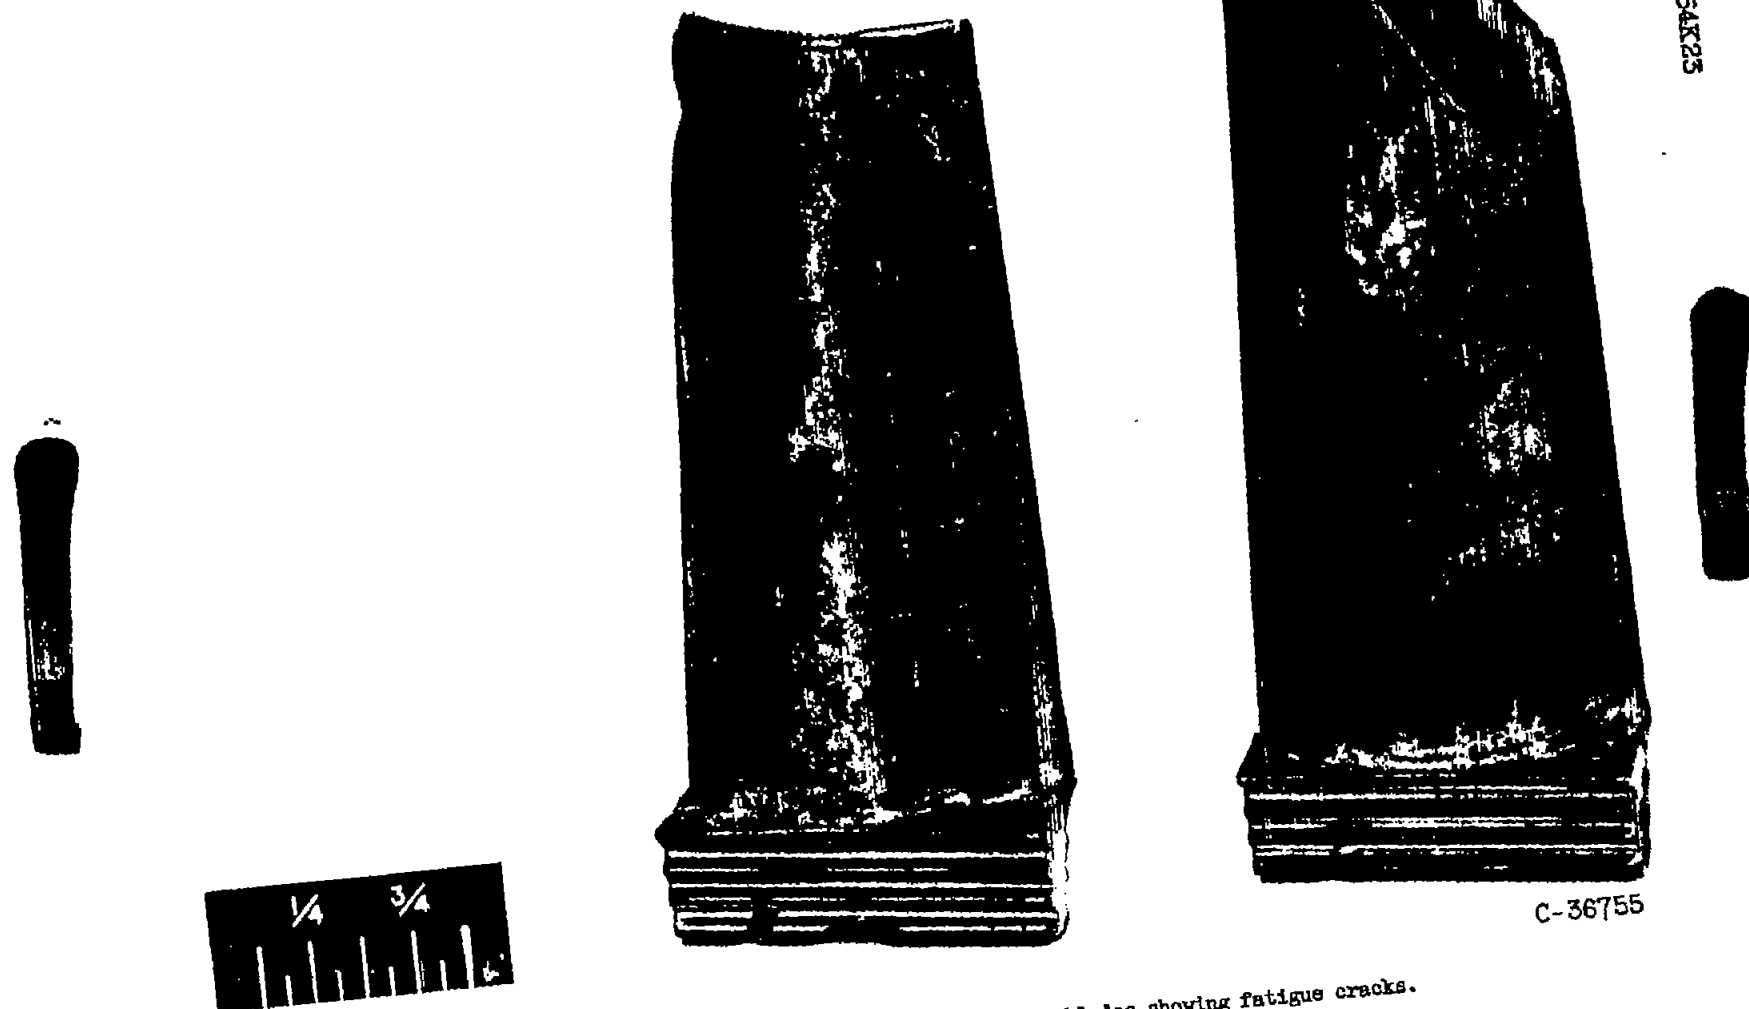
Group 10. - (A-286, 0.030-in. wall, welded airfoil salt-bath brazed to stub, fig. 3, base A.) One blade survived 29 hours of operation before removal from the test because of cracks in the airfoil tip. Three other blades sustained similar failure in shorter operation times. One blade failed in the base as a result of defective brazing. The clearance between parts was correct but the braze material had not filled the joint. The results show that A-286 blades are relatively susceptible to tip fatigue. In addition, it is probable that special welding and brazing techniques are required. The salt-bath brazing was not entirely satisfactory. Figure 16 shows typical failures.

Figure 16. - Tip failure in Group 10 sheet-metal blades showing fatigue cracks.

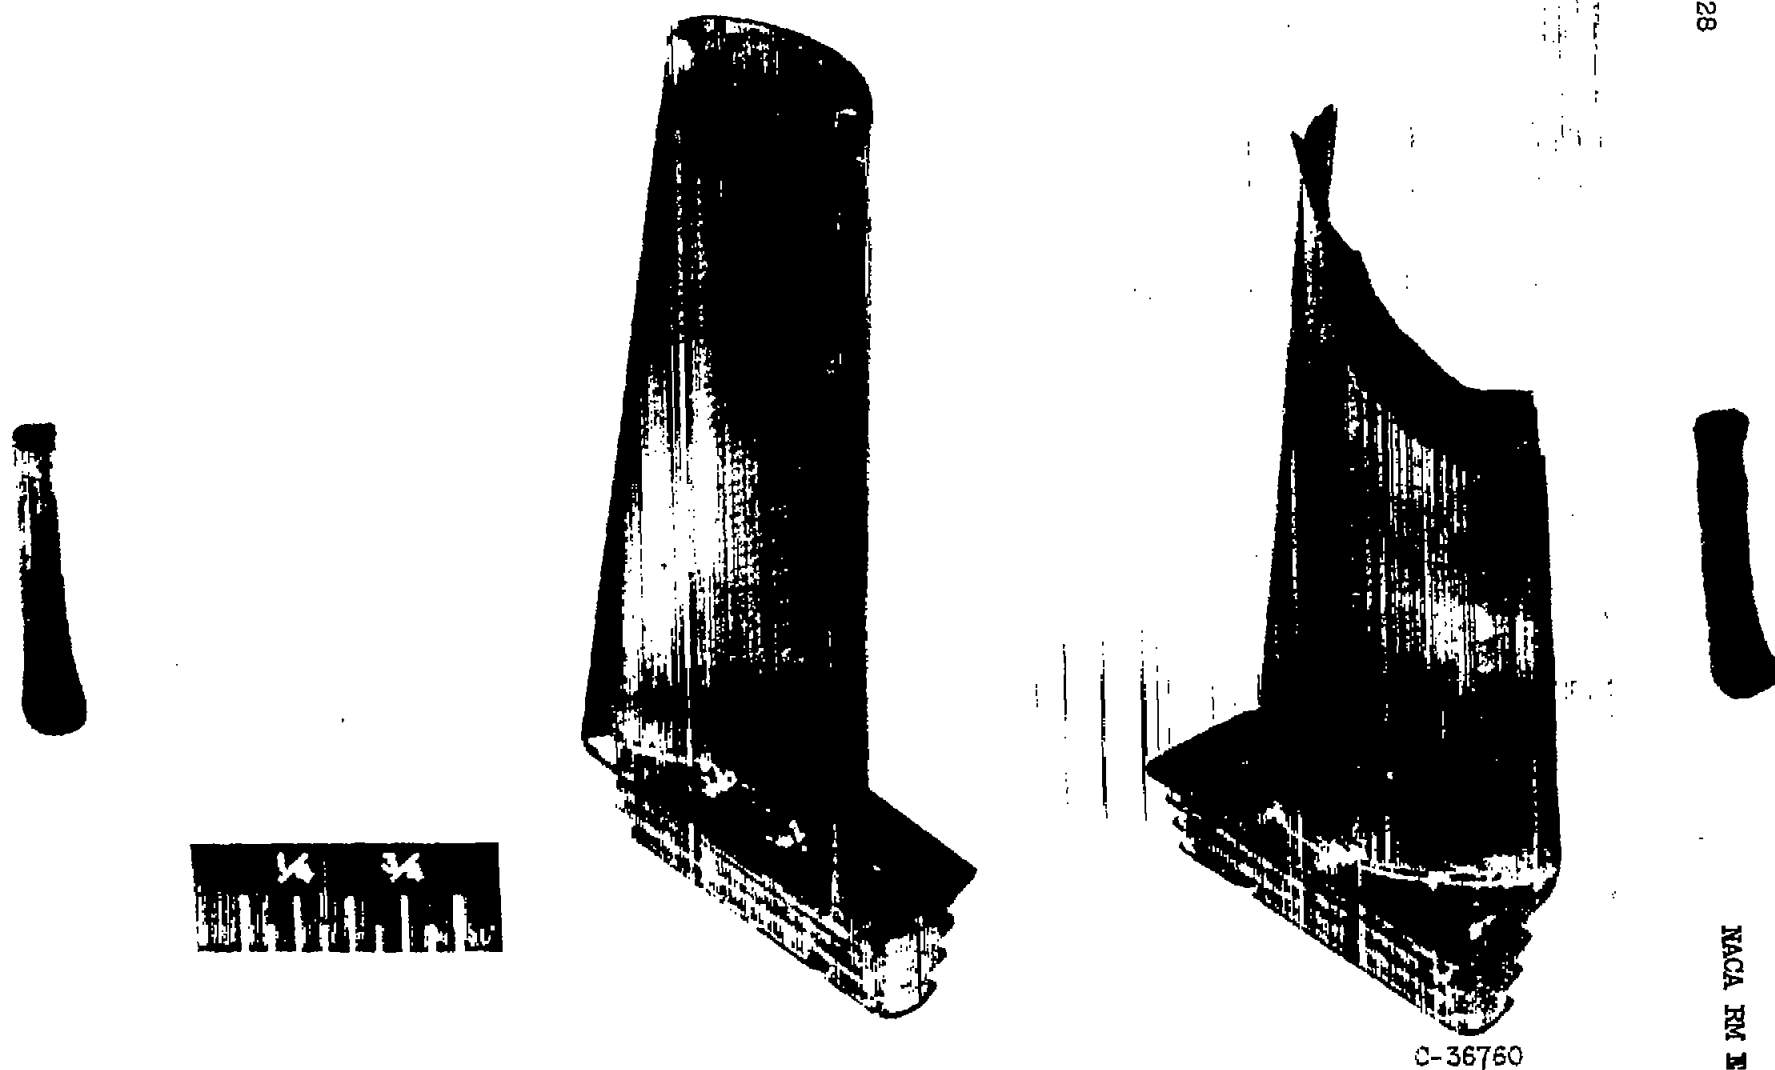
Group 11. - (L-605, 0.030 to 0.020 in. tapered wall, welded airfoil brazed to stub, fig. 3, base A.) Cracking in fatigue after short engine life characterized the failures of the six sample blades. Typical examples are shown in figure 17. The failures occurred at several locations along the airfoil. It appeared that the tapered wall was of insufficient thickness to resist vibration.

Figure 17. - Fatigue failures in Group 11 tapered-wall sheet-metal blades. (0.030-.020-in wall)

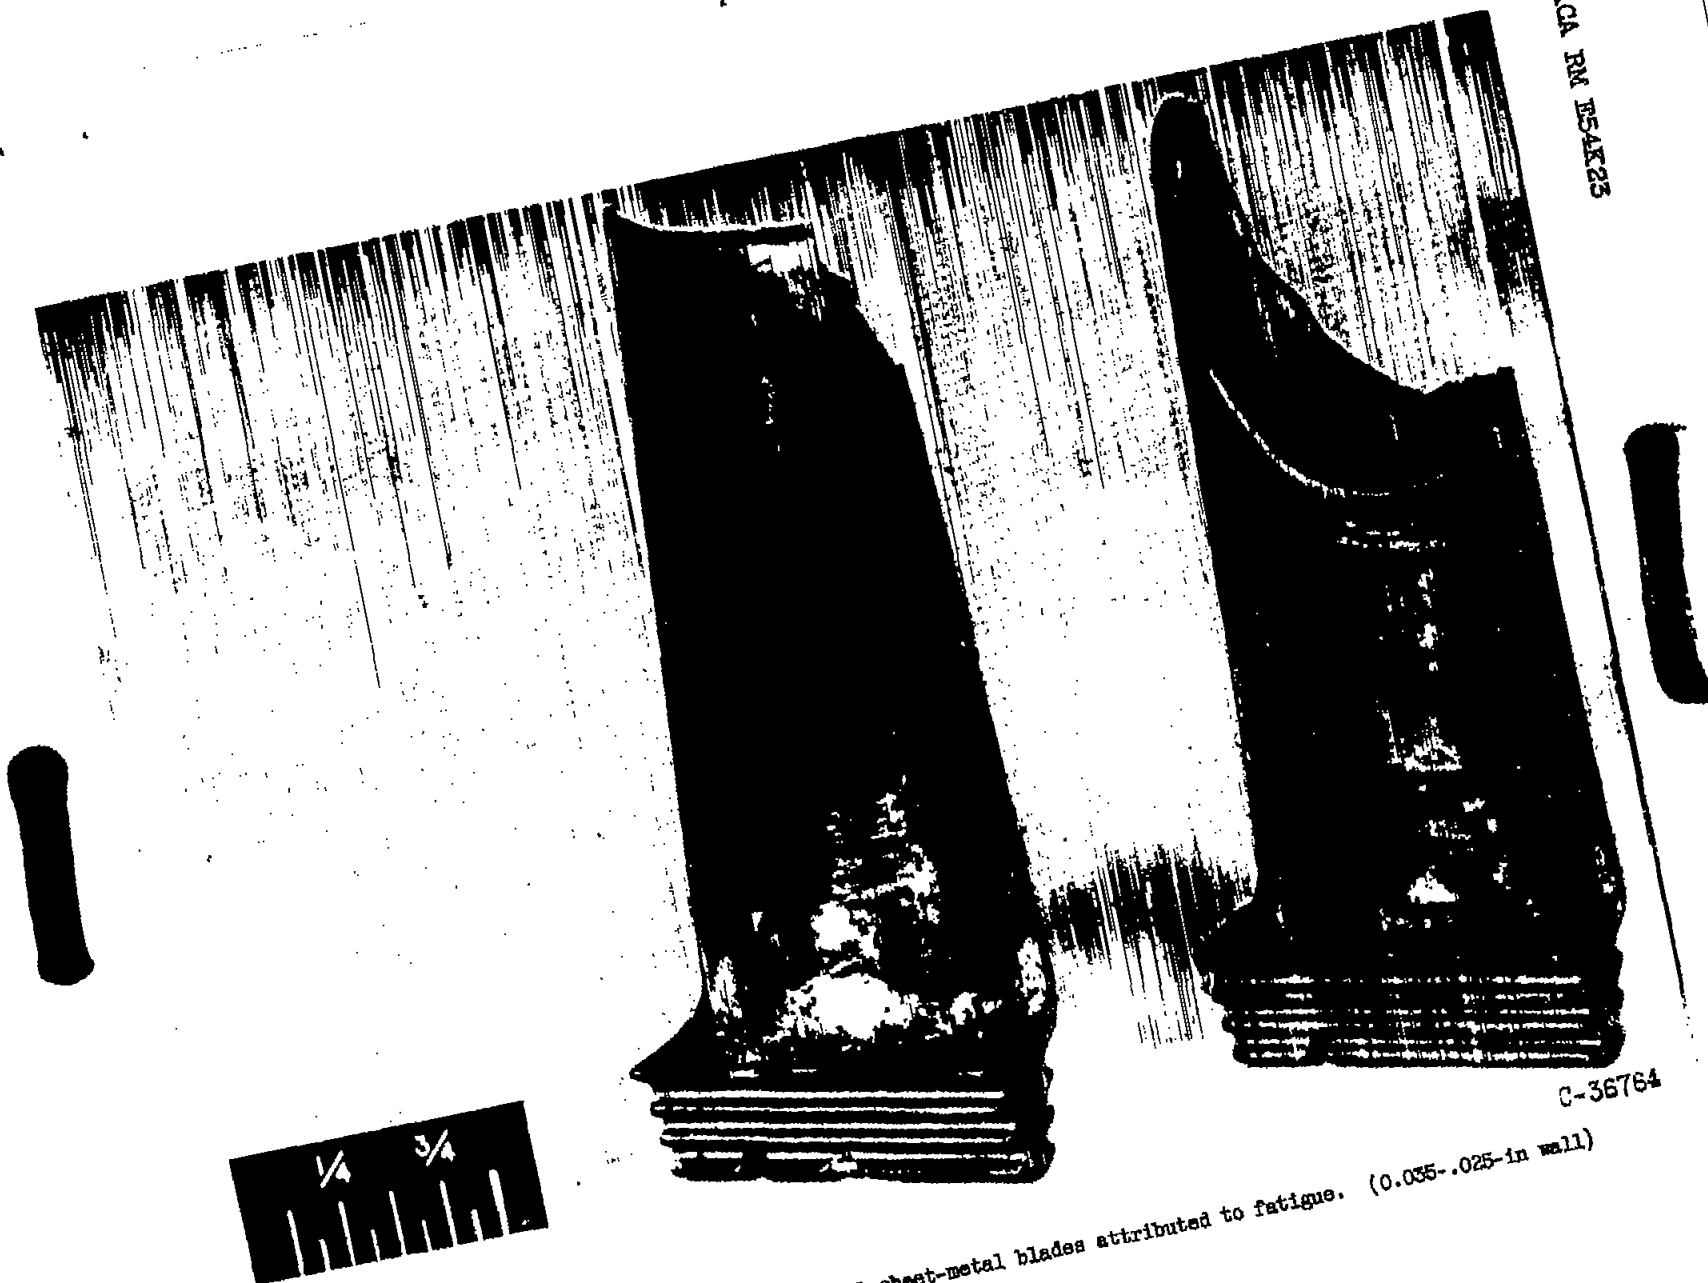
C-36764

Group 12. - (L-605, 0.035 to 0.020 in. tapered wall, welded airfoil brazed to stub, fig. 3, base A.) Three blades of this group failed in less than 10 hours of operation. The failures were all in the tip region, and were attributed to fatigue. It is possible that a welding problem exists where it is necessary to join comparatively thin sheet. On the other hand, slight variations in the machined taper may have been a critical factor. Figure 18 shows the type of failure encountered in

operation. The other three blades were still in good condition at the end of 30 hours in the engine. On the basis of these results it appeared that the wall thickness in the tip is an important factor in a design that employs tapered airfoil walls.

Figure 18. - Failures in Group 12 tapered-wall sheet-metal blades attributed to fatigue. (0.035-.025-in wall)

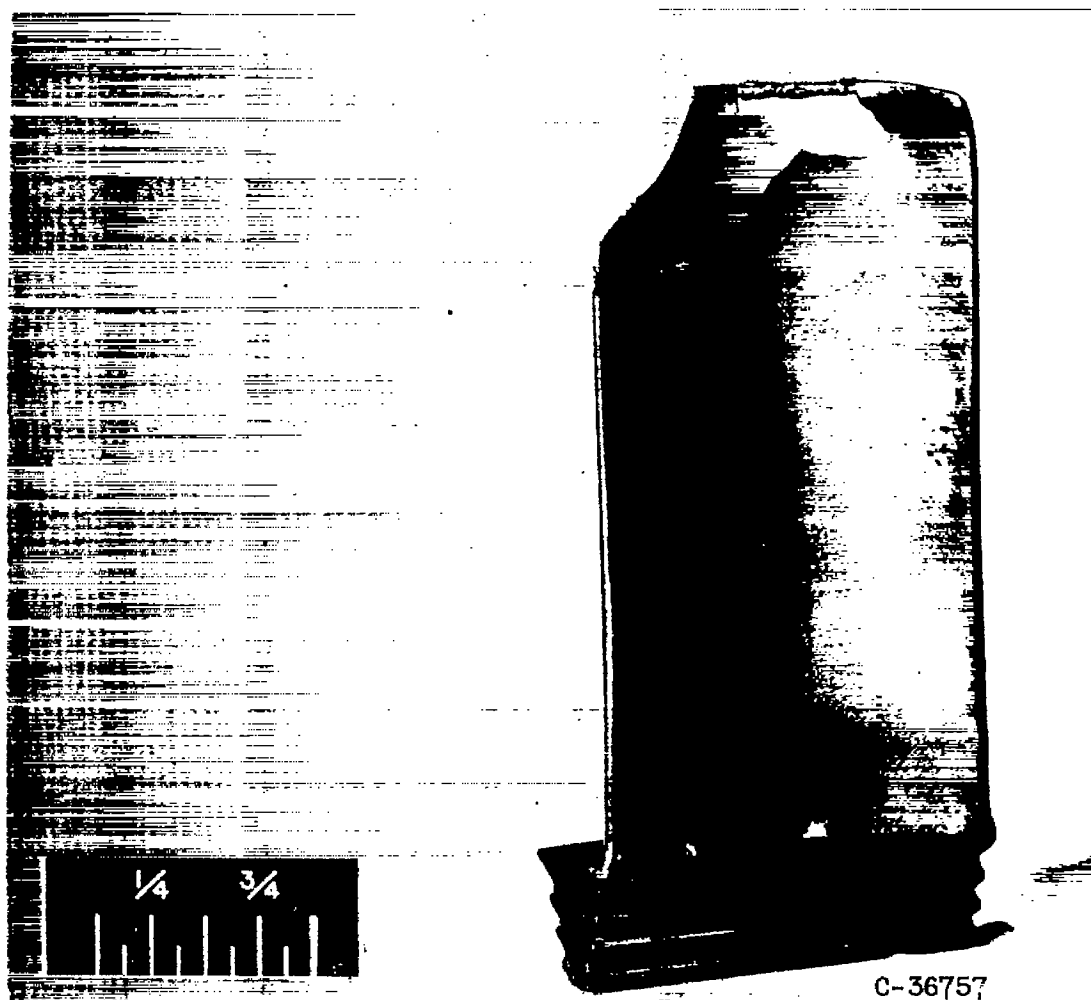
Group 13. - (L-605, 0.040 to 0.020 in. tapered wall, welded airfoil brazed to stub, fig. 3, base A.) There were five blades in this sample group; only one blade failed within the 30-hour test period. This failure occurred in the tip region after more than 29 hours and appears in figure 19. From the appearance of the failure it appeared that the crack originated in the weld. The results indicate that the proper design of tapered airfoil walls may produce satisfactory turbine blades.

Figure 19. - Group 13 tapered-wall sheet-metal blade failure attributed to fatigue.
(0.040-.020-in wall)

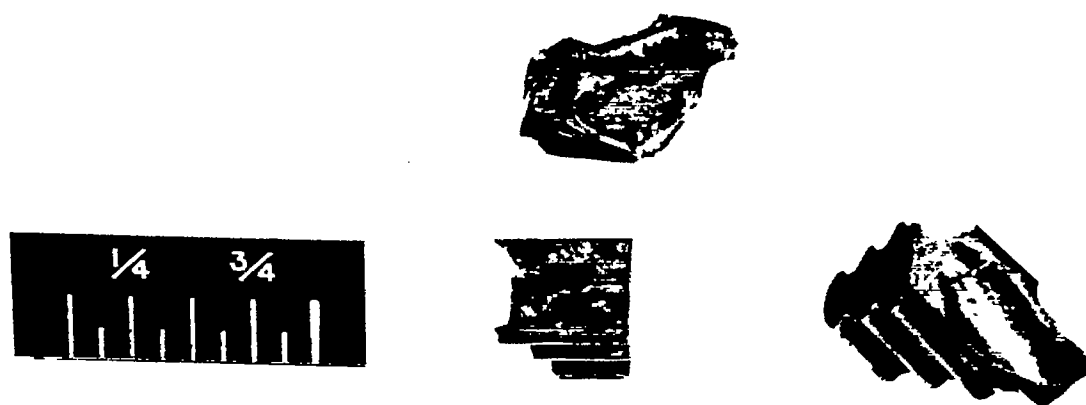
C-36765

Group 15. - (X-40, 0.055 to 0.030 in. tapered wall, cast, modified base.) The six blades of this group were removed after 9 hours. One blade had failed in the root serration and three others showed serious cracking in this region. The two remaining blades had developed cracks in the airfoil as well as in the root. The evidence indicated that the blades of this group were subject to fatigue failure. Figure 20 shows the root-serration failure.

Figure 20. - Root serration failure in a Group 15 hollow X-40 cast blade with a modified root.

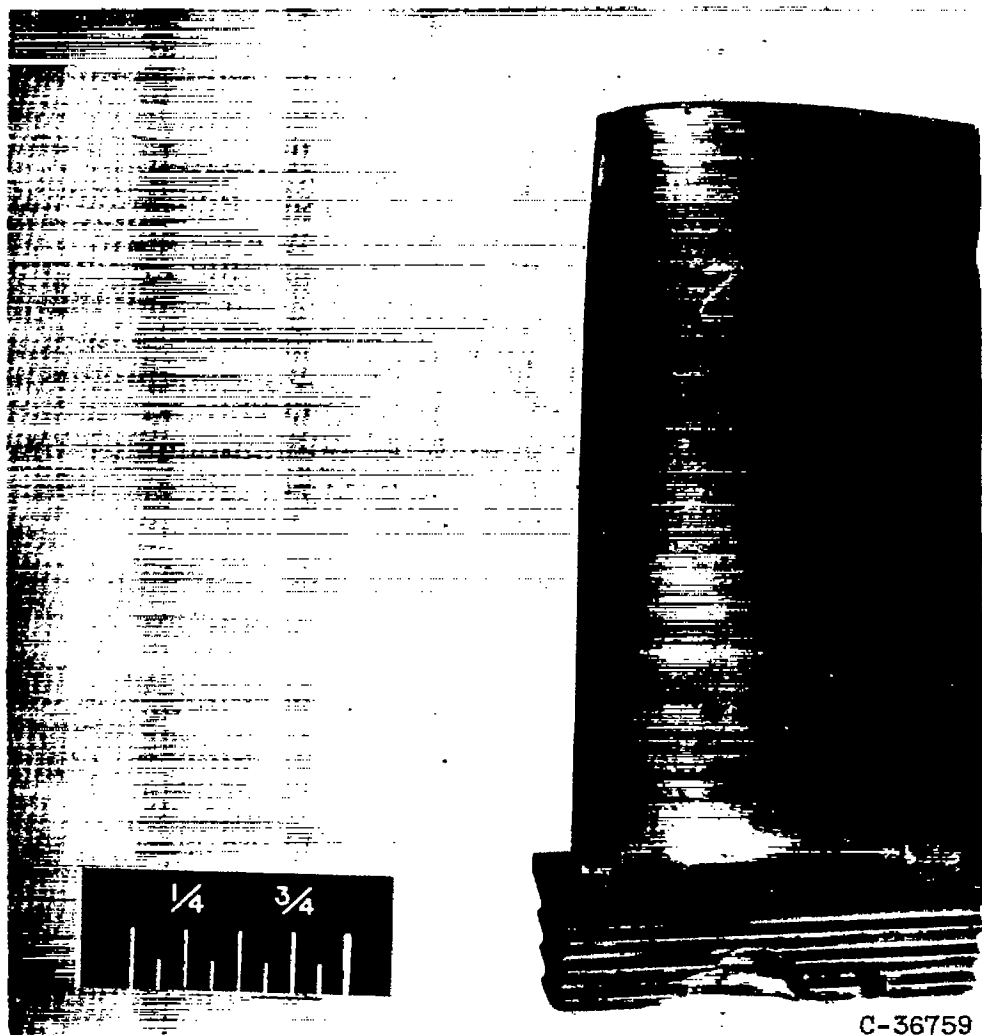
Group 16. - (X-40, 0.055 to 0.030 in. tapered wall, cast, standard base.) At the end of 20 hours of engine life the sample of four blades was removed. Three of the blades had developed fatigue cracks in the tips; the fourth blade also appeared to be cracked by vibration, but may have been damaged by impact. Typical failure is shown in figure 21. The X-40 blades in the as-cast condition are susceptible to fatigue.

Figure 21. - Fatigue crack in a Group 16 hollow X-40 cast blade.

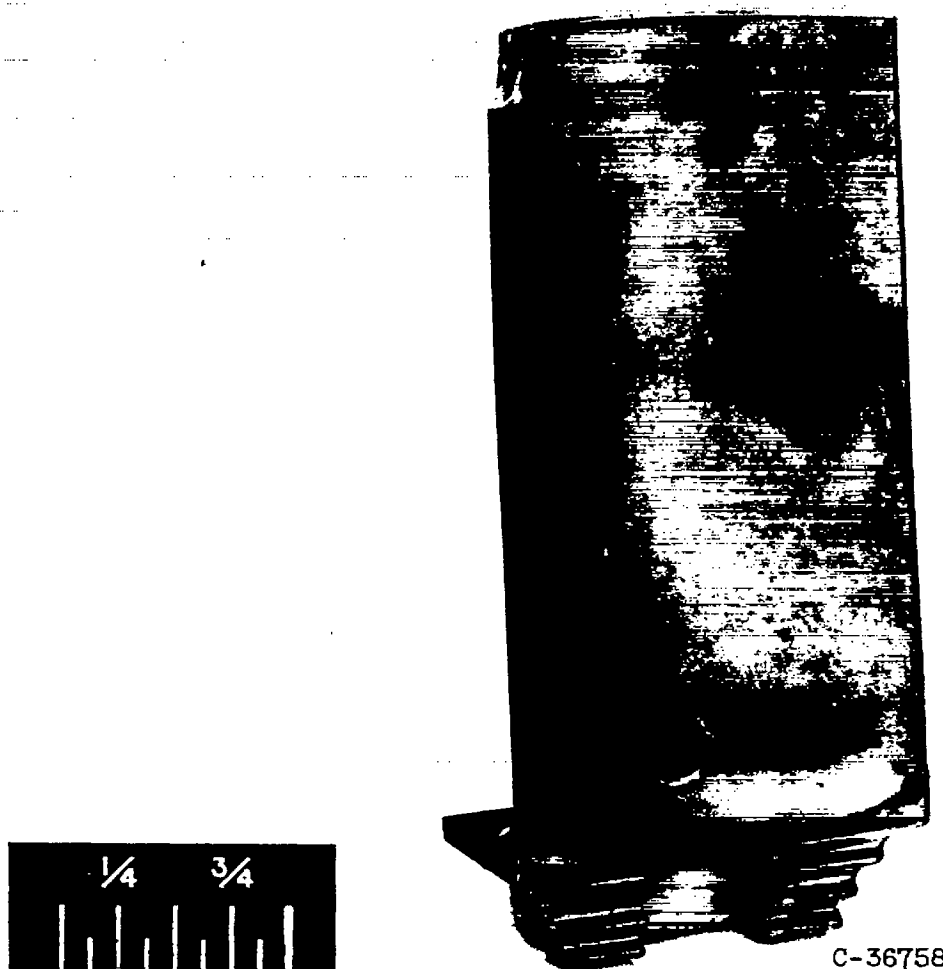
Group 17. - (X-40, 0.055 to 0.030 in. tapered wall, cast, heat-treated, shot-peened modified base.) After 24 hours of operation four of the eight sample blades were removed. These blades had fatigue cracks in the tips. The remaining four blades survived 30 hours of operation, although inspection of the bases revealed evidence of cracking in the root serrations. Figure 22 shows one of the failures. A comparison of these results with those obtained from the group 15 tests indicates that considerable improvement in the quality of X-40 cast blades can be obtained by proper heat-treatment and work-hardening of the root. There was less tendency toward tip failure by fatigue, and root-cracking was reduced.

Figure 22. - Fatigue failure in the tip of a Group 17 hollow X-40 cast blade that had been heat treated and shot-peened in the root section.
